Fashions R Boutique

9844 West Florissant Avenue

Dellwood, St. Louis County, MO

Re: Phase I Environmental Site Assessment

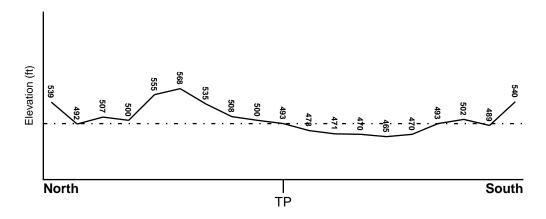
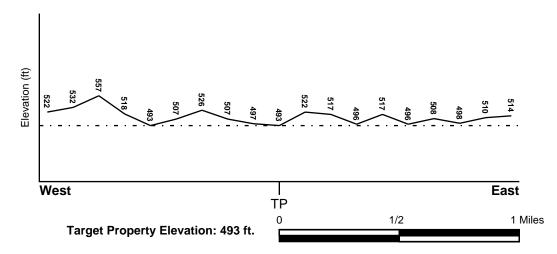
SURROUNDING TOPOGRAPHY: ELEVATION PROFILES

General Topographic Gradient: General South

Source: Topography has been determined from the USGS 7.5' Digital Elevation Model and should be evaluated on a relative (not an absolute) basis. Relative elevation information between sites of close proximity should be field verified.

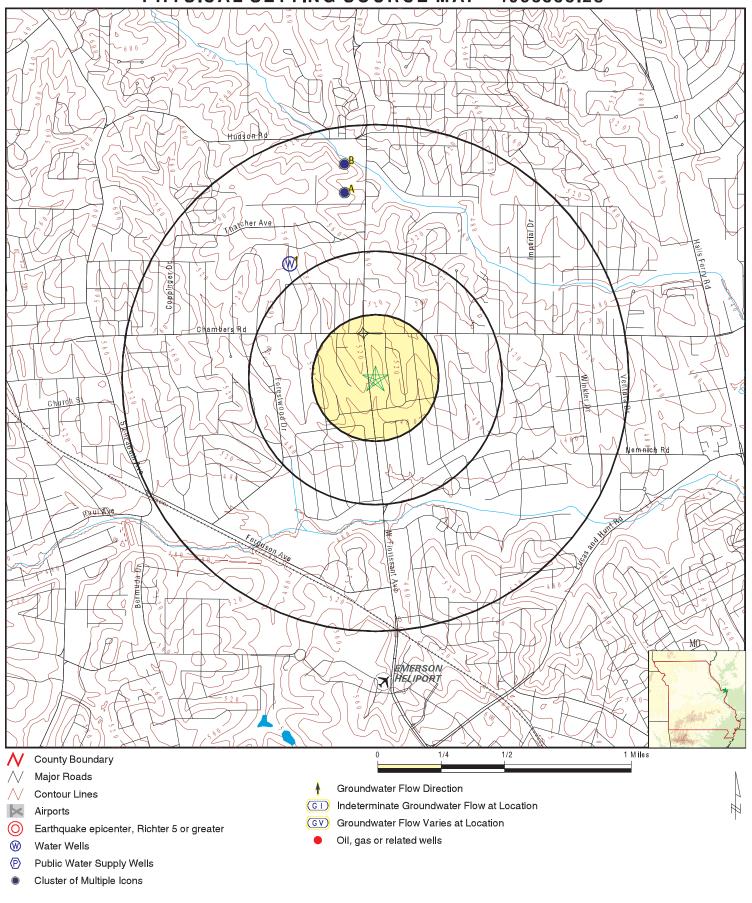
PHYSICAL SETTING SOURCE MAP - 4958333.2s

MAP ID	WELL ID	LOCATION FROM TP
1	MOLOG1000019248	1/2 - 1 Mile NW
A3	MOLOG1000019278	1/2 - 1 Mile NNW
B5	MOLOG1000019297	1/2 - 1 Mile North
